Downtown Rail Reconstruction Project

Week in Review

Friday, October 17, 2025

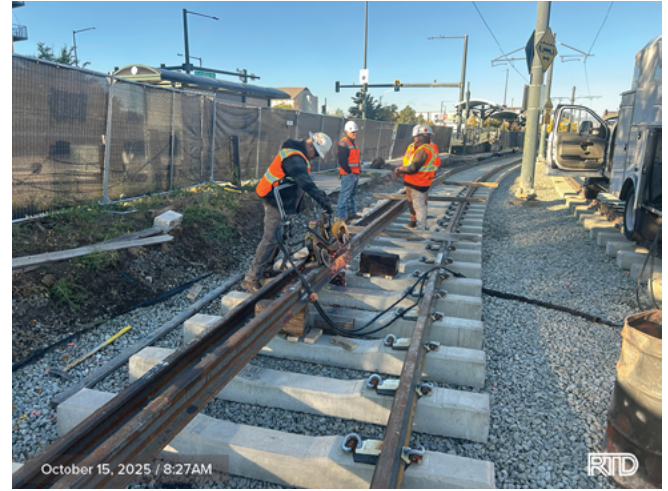
2 | Grinding Rail

Kalamath Street Crossing | Oct. 15, 8:27 AM

Certified welding crews performed more **thermite welds** this week, completing a total of 62 welds so far. Crews used a **weld shear** to cut the **excess metal** from the welds before using **rail profile grinders** to shape the weld to match the rail profile. Crews also took samples of **ballast** this week to perform gradation testing.

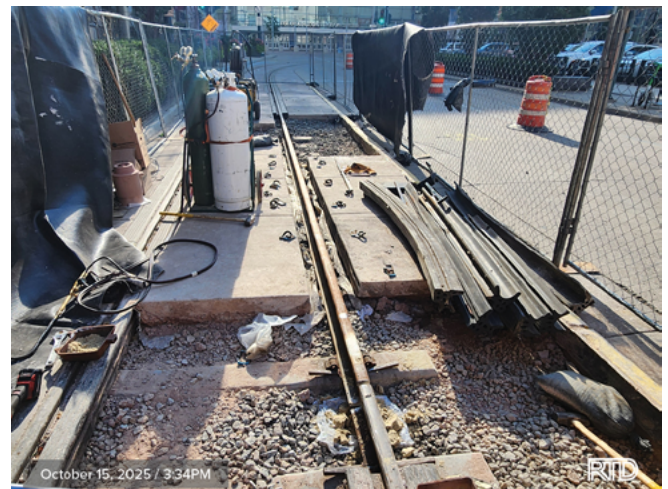
Other crews began work on a rail repair near **14th and California Streets**. Like most metals, steel rails expand and contract with **temperature fluctuations**. When temperatures drop quickly, the metal **contracts**, and with a large enough temperature swing, this can cause the rail to **break** at weaker locations, like welds. This repair work addresses a rail break that happened in January of this year.

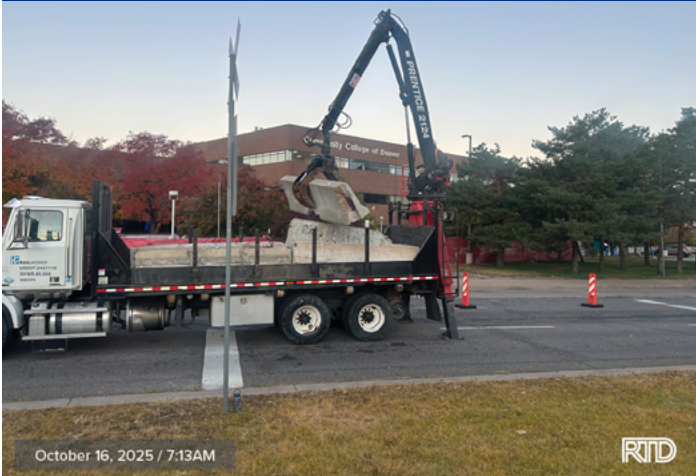
Concrete Jersey Barriers

Kalamath Street Crossing | Oct. 16, 7:13 AM

Crews delivered **concrete Jersey barriers** to site this week in preparation for the **full closure** of Kalamath Street, starting **Sunday, Oct. 19**. The barriers will be placed strategically to minimize the likelihood of vehicles accidentally crossing into the work area during the full street closure.

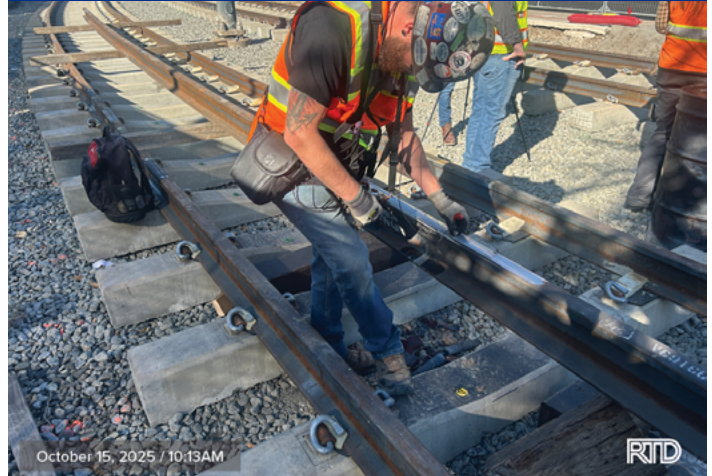
Ultrasonic Testing

Kalamath Street Crossing | Oct. 15, 10:13 AM

Crews performed **ultrasonic testing** and **magnetic particle testing** on completed welds. These tests are performed on all welds before returning the rail to service. **Certified testers** inspected each weld and documented the test results as a part of the **quality control** process. Test results were written directly on the rail next to each weld.

Ultrasonic testing is a non-destructive method of detecting **internal defects** within the rail. To perform this test, a technician uses a machine and a specialized **transducer** to send high-frequency waves into the rail. Parts of the wave reflect back to the transducer if there are any **discontinuities** in the weld, indicating a potential defect. If a defect is detected, that section of the rail is cut out and the rail is re-welded.
