Friday, November 7, 2025

#### Overview:

# Kalamath Street Crossing 86-Day Schedule

Full-Depth Rail Reconstruction

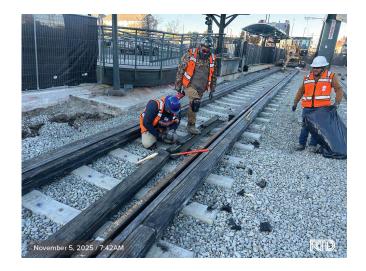
1 | Installing Flangeway Filler Kalamath Street Crossing | Nov. 5, 7:42 AM

This week, crews applied **anti-corrosion petrolatum** to each of the over 2,000 e-clips to help protect the metal from **rust** and environmental damage. They then installed over 5,000 linear feet of **flangeway filler** on tracks A and B. Flangeway filler was trimmed by hand to fit tightly around the bolted restraining rail connections.

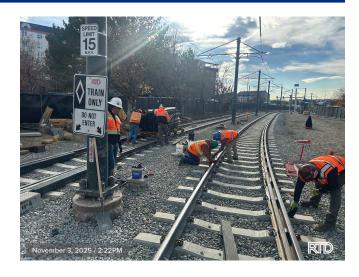
**2** | **Anti-Corrosion Petrolatum** Kalamath Street Crossing | Nov. 3, 2:22 PM

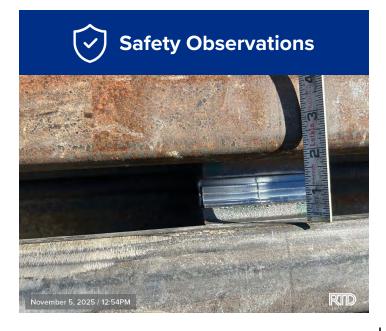
Inspectors completed the **safety certification** of the **restraining rail gap**, confirming that the space between the two rails meets tolerance requirements at all points. Restraining rail is a critical **safety component** of **special trackwork** that prevents train wheels from derailing around tight curves, and reduces the wear on the running rail. Crews have installed **1,100 linear feet** of restraining rail across both tracks.

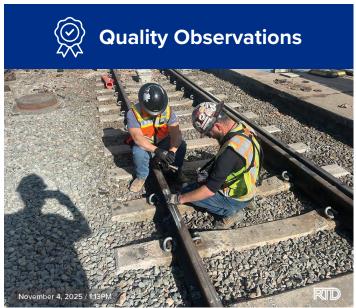
**Ultrasonic Testing**Kalamath Street Crossing | Nov. 4, 1:13 PM

Crews completed additional **ultrasonic testing** on the final welds made last weekend. Out of the total **81 welds** performed on the project, one did not pass inspection. The team cut out the failed section of rail and made a new weld to replace it.

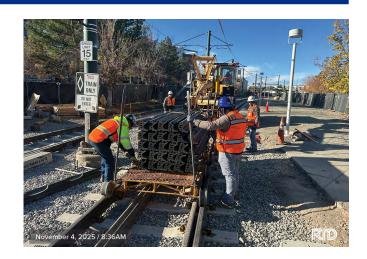
Flangeway filler is the rubber material used to "fill in" and reduce the gap between the rail and surrounding concrete, while leaving space for train's wheel flange to pass by. It is used in areas of paved track and vehicle crossings, where it helps prevent bicycles, wheelchairs, and scooters from getting stuck in this gap. In addition to improving safety for vehicles and pedestrians, flangeway filler prevents dirt, snow, and debris from accumulating in the flangeway.
