## Denver Union Station System Upgrades

Replace overhead contact wires that provide electricity to move the trains.

# Denver Union Station System Upgrades

The **Regional Transportation District (RTD)** replaced overhead electrical wires Saturday, April 11 through Monday, April 13 at **Denver Union Station**. As a part of the **Building a Better RTD** strategic initiative, this proactive maintenance will ensure safe and reliable operations for the agency's **E** and **W light rail** lines.

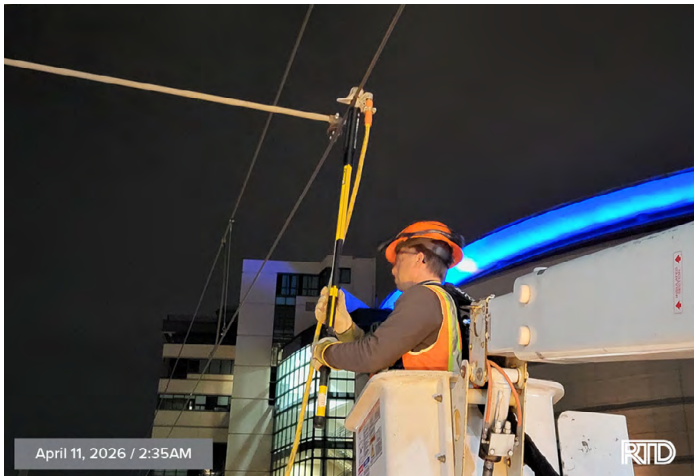
**Grounding the Overhead Wire**  
Ball Arena | April 11, 2:35 AM

After powering down the OCS and prior to starting removal work, crews used a tool called a **"hot stick"** to attach a ground cable to the overhead wires. The other end of the large grounding cable was clamped to the rail head and crews used a **voltage meter** to confirm that zero volts of electricity are detected in the wires prior to beginning work on the system. The use of the grounding cable gives personnel working on the alignment a visual indicator that the power remains off. This can be very important during shift changes during the work.
