# Downtown Rail Reconstruction Project

## Week in Review

Friday, October 24, 2025

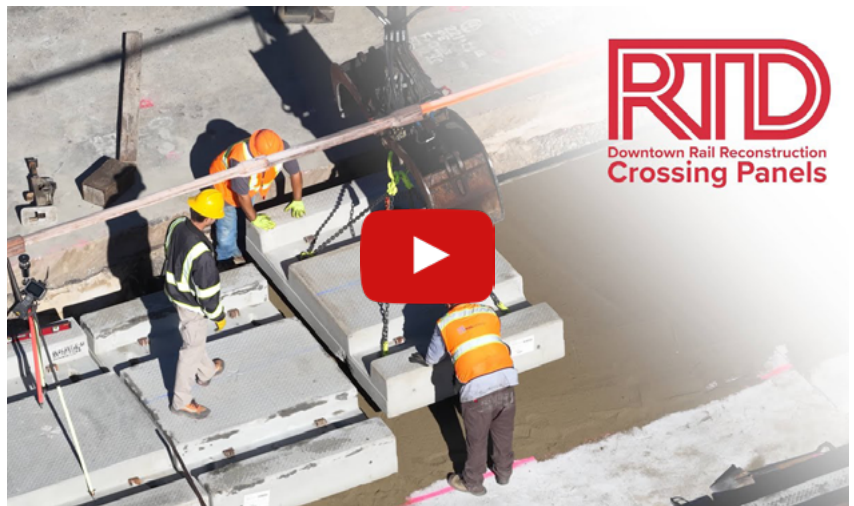
This week, crews **demolished** and began **reconstruction** of the light rail crossing on **Kalamath Street**. Reconstruction so far has included pouring a **concrete leveling slab**, placing **32 crossing panels**, and installing **rail**. Crews are working on pouring **track paving** and approach slabs in Kalamath Street. Work remains **on schedule**.

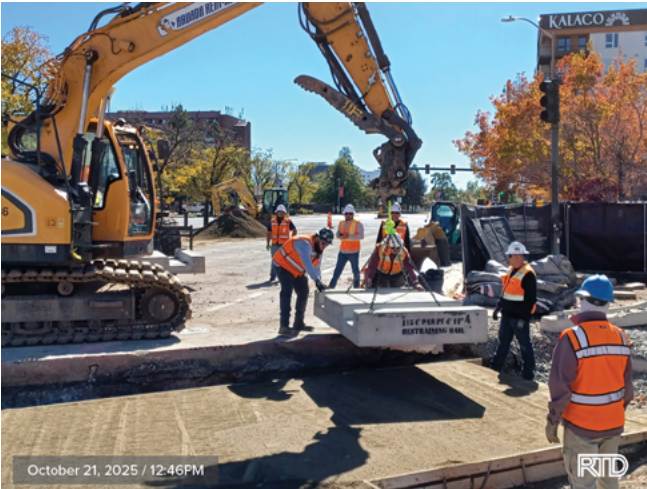
Kalamath Street Crossing | Oct. 21, 12:47 PM

### 1 | Placing Crossing Panels

On Monday, crews formed and poured a **concrete leveling slab** spanning the entire vehicle crossing on Kalamath. Once cured, this concrete served as the foundation for the **32 crossing panels** that hold the rail. After placing the panels, crews began installing **rail, clips, and rubber flangeway filler** for both tracks. On Thursday morning, crews began forming and pouring concrete approach slabs and track paving in the intersection.

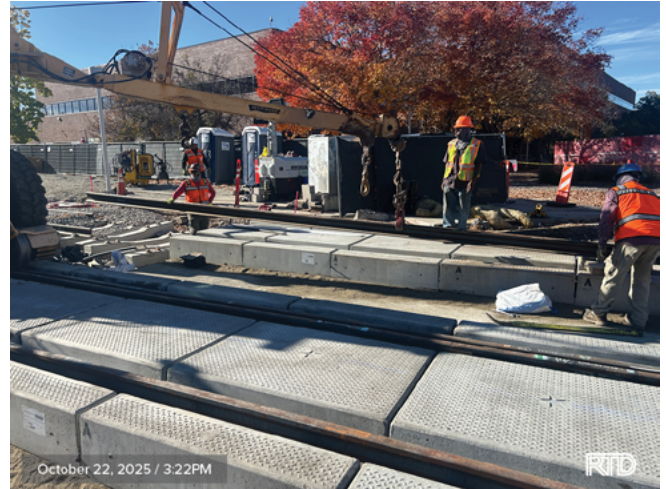
Kalamath Street Crossing | Oct. 22, 3:22 PM

### 2 | Installing Rail on Panels

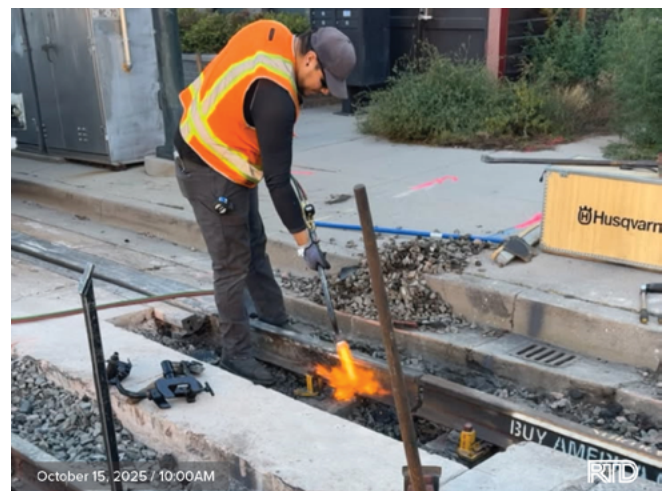
**RTD Maintenance of Way** performed thermite welding at switch 21A near **24th and Welton Street** last week. After 30 years of use, the **insulated joint** at this location was in need of attention. Crews removed the surrounding track paving, preheated the rail, and welded the connection using the same **thermite welding** process as seen at the Kalamath Street crossing. They then ground the weld smooth to match the rail profile.

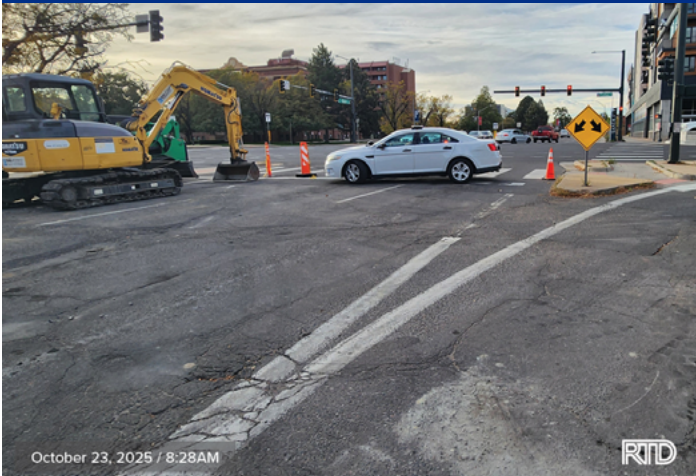
### Uniformed Traffic Controller

Kalamath Street Crossing | Oct. 23, 8:28 AM

**Uniformed traffic controllers** (UTCs) have been present on site at the intersections of Kalamath Street and Colfax Avenue and at Kalamath Street and Speer Boulevard during morning and evening **rush hours**. UTCs have provided additional **support** to manage **traffic flow** around the construction area.

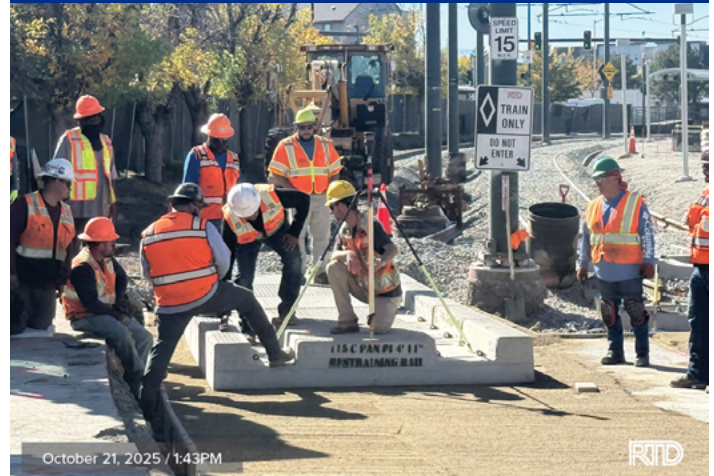
Kalamath Street Crossing | Oct. 21, 1:43 PM

### Surveying Panel Placement

**Surveyors** verified the exact placement of the concrete crossing panels as they were installed. They checked the top **elevation** as well as the **alignment** of each panel against the **engineer's design drawings**. The rails are clipped directly to embedded metal "shoulders" in each panel, so placement has to be precise to ensure that the rails are aligned correctly.

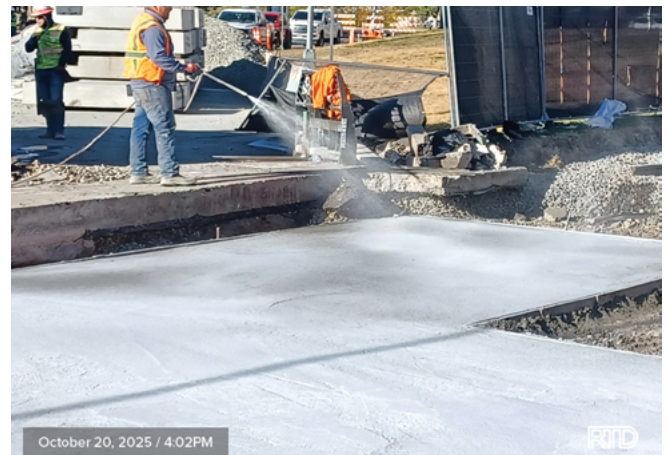
**Curing** is the process through which concrete develops its properties of **strength** and **durability**. Once water is mixed with Portland cement, a chemical reaction called **hydration** begins. The concrete increases in density, strength, and durability as the cement hydrates. Products like **concrete blankets** or **curing compounds** can be used to manage the **temperature** and **moisture** of the concrete as it cures and to help ensure the concrete cures properly.
